# Manhole Inspection Summary

Manhole # S37KK\_030MH

Insp Date: **3/19/07 11:53 AM**

**Location** Address: **1803 BARCLAY ST**

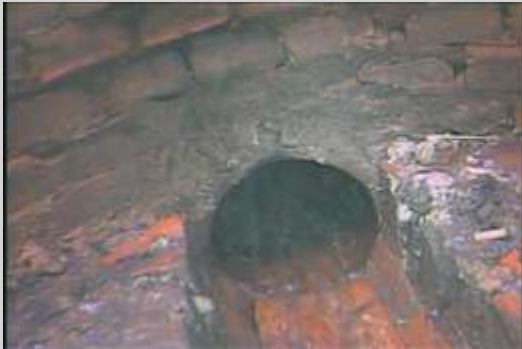
### 8 in. Circular Gravity Sewer Pipe Out @ 12 O'Clock

Rod and Bar (Angled)

Pipe Material: **Clay** ☐ Pipe Lined

Infiltration: **None** Pipe Seal Cond: **Unknown**
